# Manhole Inspection Summary

## Manhole # S31MM1013MH

Insp Date: **8/20/08 1:20 PM**

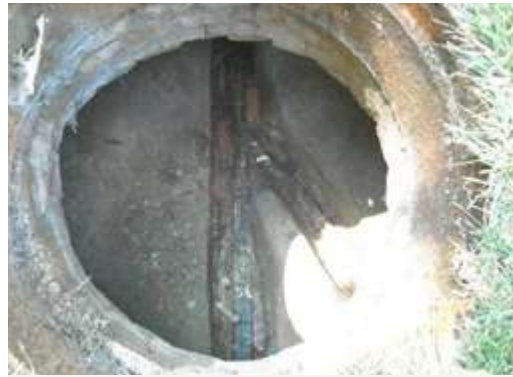
Top View

**Frame** Offset: **1** (in.) Condition: ☐ Sound ☐ Cracked ☒ **Leaks**

Condition: ☐ Sound ☐ Cracked ☐ Root Intrusion ☐ Loose Brick ☒ **Deteriorated**

Infiltration: ☐ None ☒ **Joint** ☐ Cracks ☒ **Mortar** ☐ Roots ☐ Wall

**Surcharge** ☒ **Evidence Of Surcharge** Depth: **1** (ft.) ☐ Active Surcharge Present

Frame leaks. Corbel deterioration and infiltration. Evidence of surcharge - Bench debris. Channel debris.

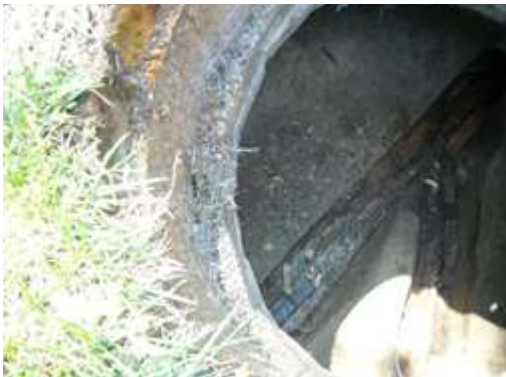
Defect

**Cover** Shape: **Circular** Diameter: **24** (in.) Length: (in.) Dist A/B Grade: **1** (in.)

Frame leaks. Frame offset.

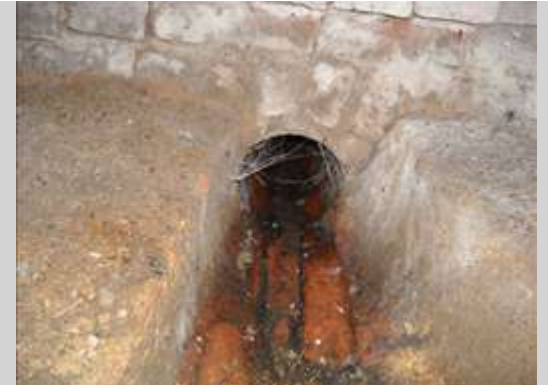
### 6 in. Circular Gravity Sewer Pipe Out @ 12 O'Clock

Pipe Material: **Clay** ☐ Pipe Lined

Invert Depth: **4.55** (ft.) Flow Characteristics: **None**

Deposits: ☒ None ☐ Mud ☐ Sludge ☐ Debris ☐ Grease

Infiltration: **None**

Pipe Seal Cond: **Sound**

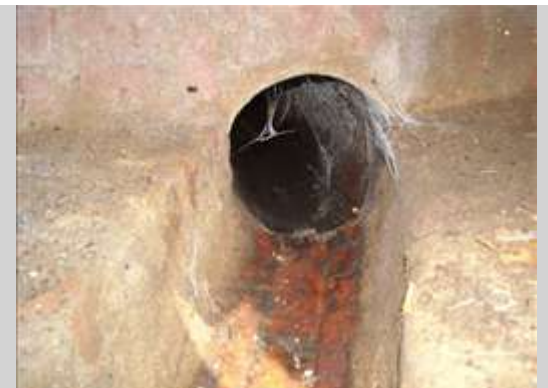
### 6 in. Circular Gravity Sewer Pipe In @ 4 O'Clock

Pipe Material: **Clay** ☐ Pipe Lined

Invert Depth: **4.32** (ft.) Flow Characteristics: **None**

Deposits: ☒ None ☐ Mud ☐ Sludge ☐ Debris ☐ Grease

Infiltration: **None**

Pipe Seal Cond: **Unknown**

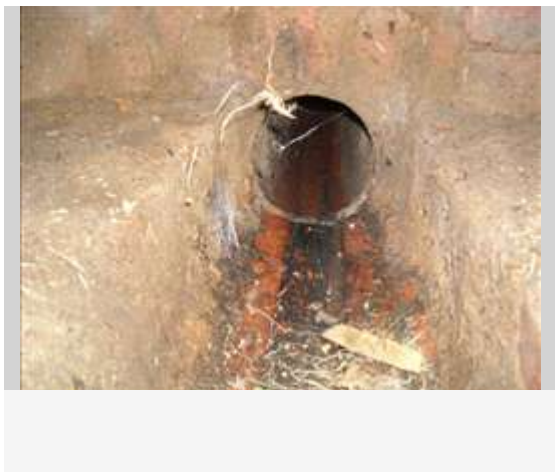
6 in. Circular Gravity Sewer  
Pipe In @ 6 O'Clock

Pipe Material: **Clay** ☐ Pipe Lined

Invert Depth: **4.40** (ft.) Flow Characteristics: **None**

Deposits: ☒ None ☐ Mud ☐ Sludge ☐ Debris ☐ Grease

Infiltration: **None** Pipe Seal Cond: **Unknown**
